# Discovery Report

Customer Ref. No. : ODL 23-000000329  
 Olympus Ref. No. : 51883155

Model : GIF-H190N  
 Serial No. : 2102210  
 Customer Asset ID :

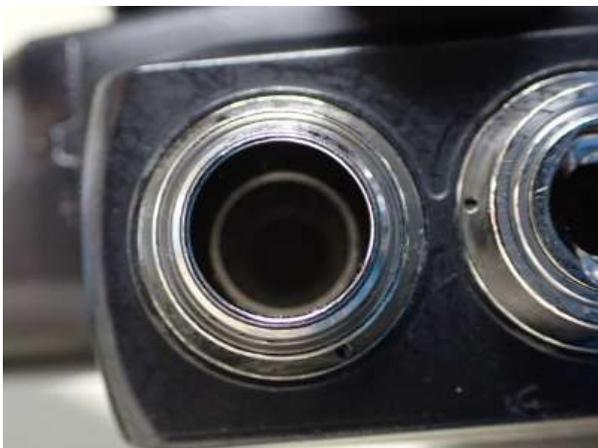
No.	Result	Repair Contents	Condition
Overall Appearance			
29	Non Critical	AW-cylinder	Appearance defect
		AW-cylinder has discoloration.

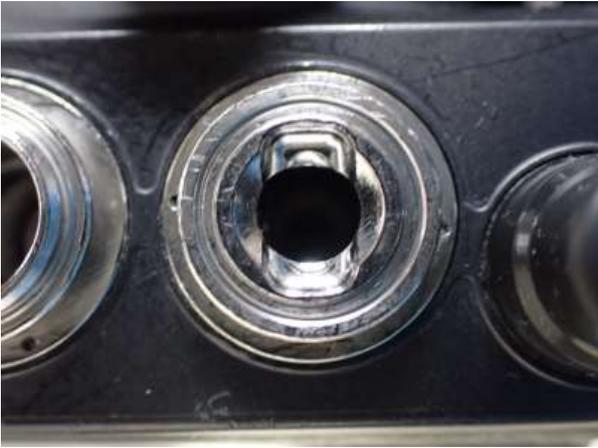
No.	Result	Repair Contents	Condition
Overall Appearance			
29	Non Critical	S-cylinder	Appearance defect
		S-cylinder has discoloration.

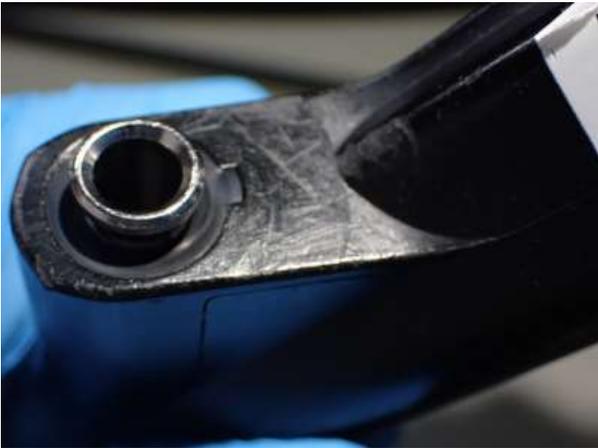
Overall Appearance			
29	Non Critical	Grip	Crack, damage or deformation of parts
		Grip is shaved.

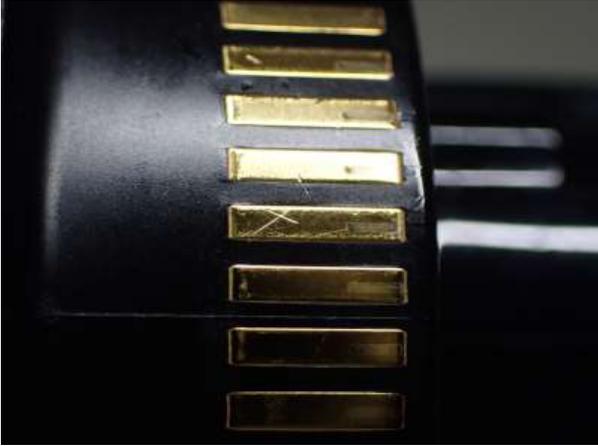
No.	Result	Repair Contents	Condition
29	Non Critical	Plug unit	Crack, damage or deformation of parts
		Plug unit has a scratch.

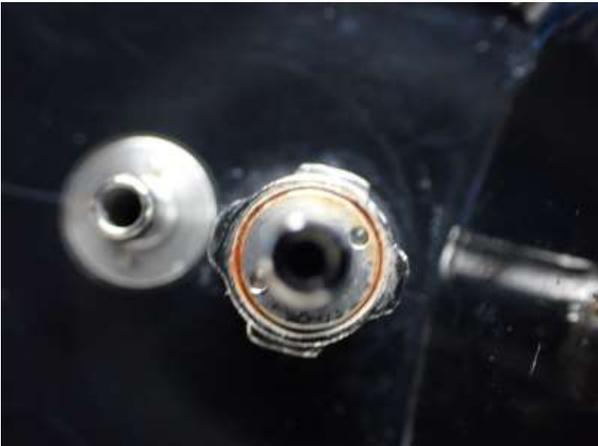
29	Fail	Mouthpiece	Appearance defect
		Mouthpiece has corrosion.

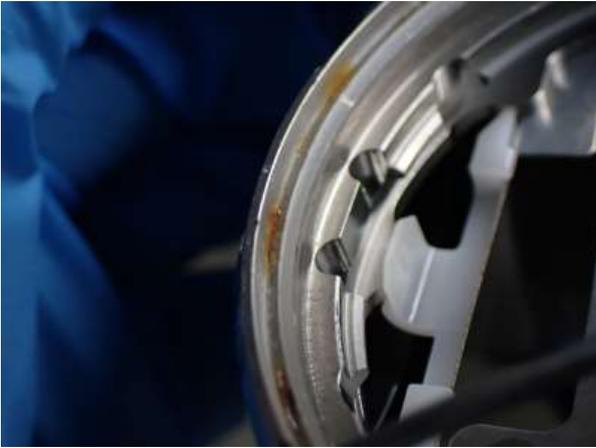
No.	Result	Repair Contents	Condition
Water Leakage Stain Inspection (S-connector, 190/185/290-Series)			
44	Non Critical	S-connector	Appearance defect
		S-connector has corrosion due to water leakage.

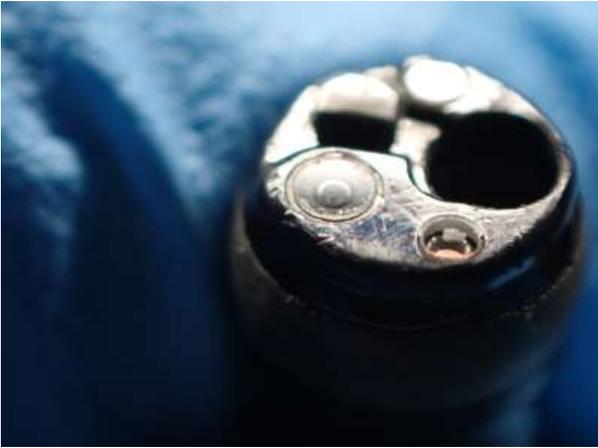
No.	Result	Repair Contents	Condition
31	<b>Fail</b>	C-cover (C-body) - Scratches, Dent, Cracks, or Snags	Crack, damage or deformation of parts
		C-cover has a dent.

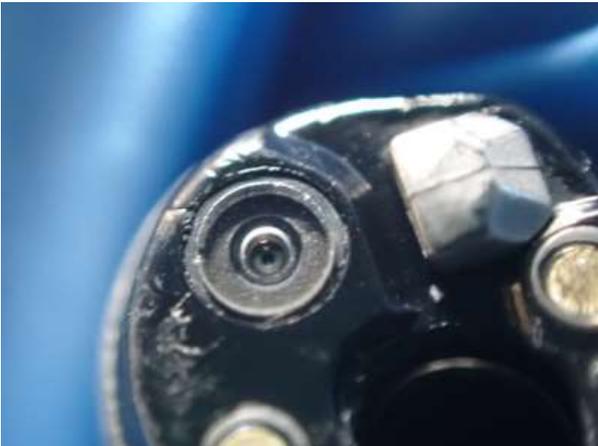
No.	Result	Repair Contents	Condition
33	<b>Non Critical</b>	Objective Lens - Cracks, Chips, Scratches, or Stain	Crack, damage or deformation of parts
		Objective lens has a chip.

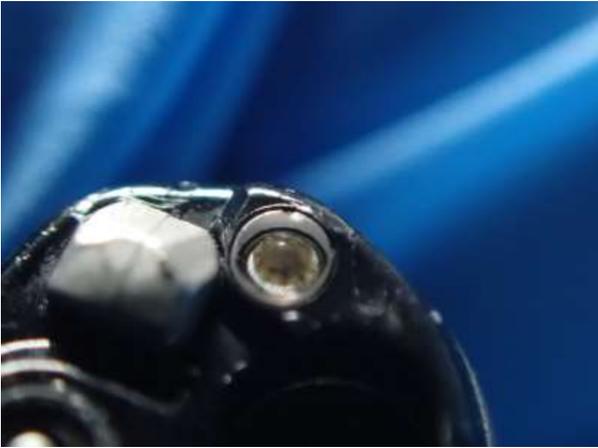
No.	Result	Repair Contents	Condition
34	<b>Fail</b>	LG Lens - Cracks, Chips, Scratches, or Stain	Crack, damage or deformation of parts
		LG lens has a crack.

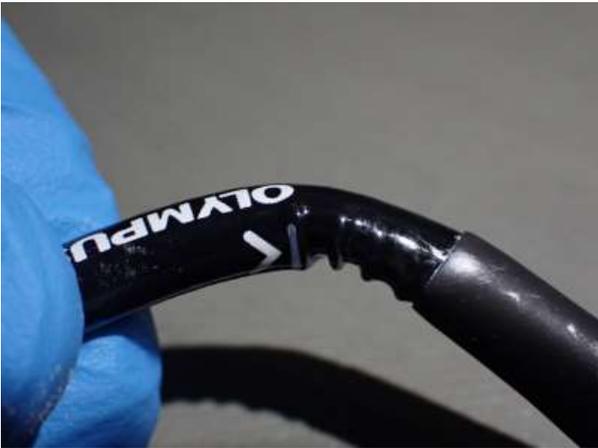
Insertion Tube Buckles and Coating Peel-off/Buckles on Protector Insertion Section			
40	<b>Fail</b>	Connecting tube	Crack, damage or deformation of parts
		Connecting tube has a buckling.

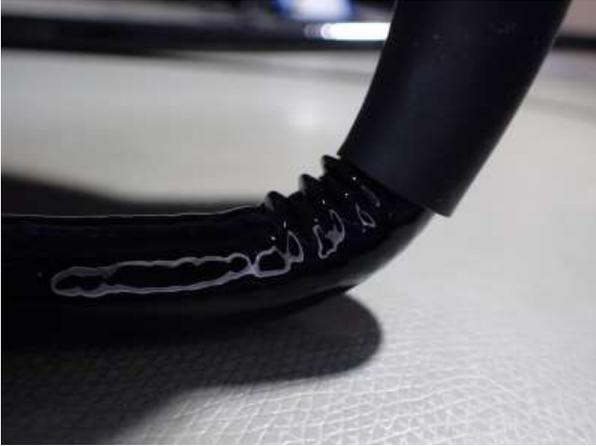
No.	Result	Repair Contents	Condition
29	<b>Fail</b>	Universal cord	Crack, damage or deformation of parts
		universal cord has buckling.
