# Discovery Report

Customer Ref. No. : ODL 23-000000329  
 Olympus Ref. No. : 51883155

Model : GIF-H190N  
 Serial No. : 2102210  
 Customer Asset ID :

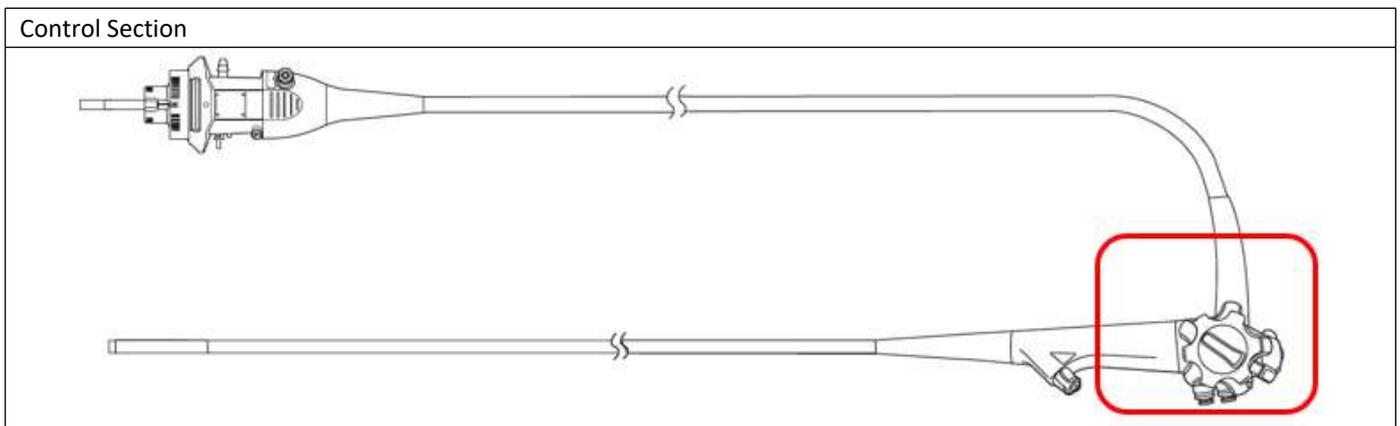
No.	Result	Repair Contents	Condition
Overall Appearance			
29	Non Critical	AW-cylinder	Appearance defect
		AW-cylinder has discoloration.

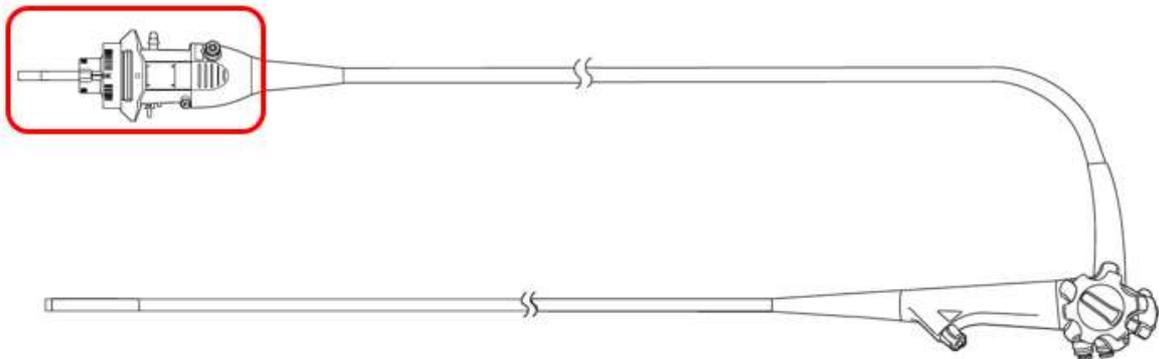
Endoscope connector

No.	Result	Repair Contents	Condition
29	Non Critical	Plug unit	Crack, damage or deformation of parts
		Plug unit has a scratch.

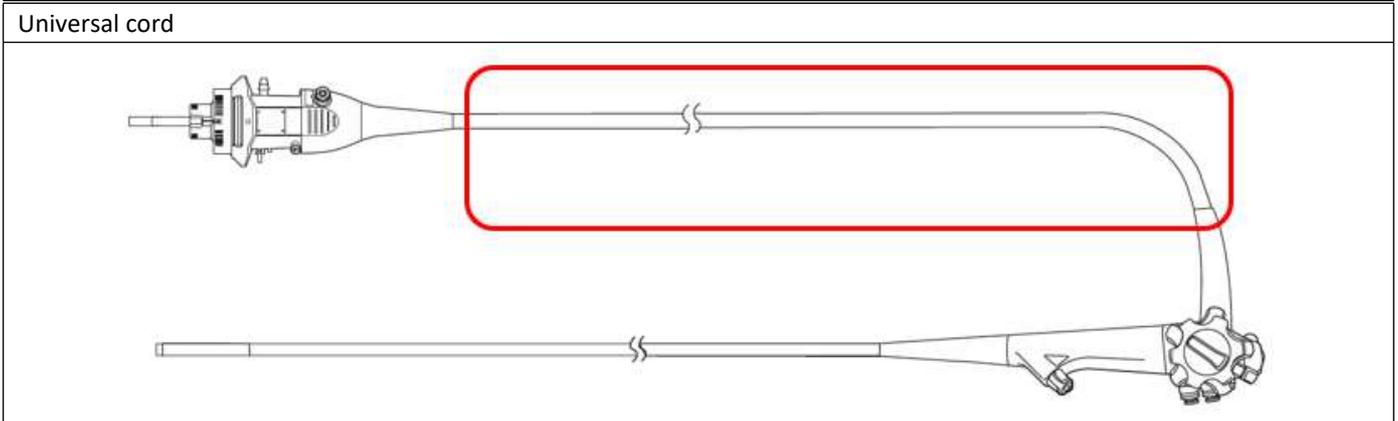
Insertion Tube Buckles and Coating Peel-off/Buckles on Protector Insertion Section			
40	<b>Fail</b>	Connecting tube	Crack, damage or deformation of parts
		Connecting tube has a buckling.
